# ***CASE STUDY: CAVITATION DAMAGE – DON'T SCRAP THEM, CORROGLASS THEM!***

## ***'CLA-VAL' NGE 400, 200 & 100 HYTROL VALVE BODIES***

Major valve supplier to the South African Water Industry

August 2010

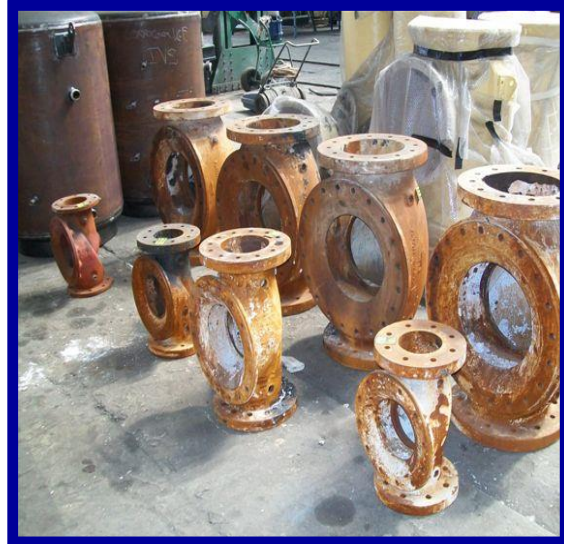
*Top: Numerous valve bodies for rehabilitation*

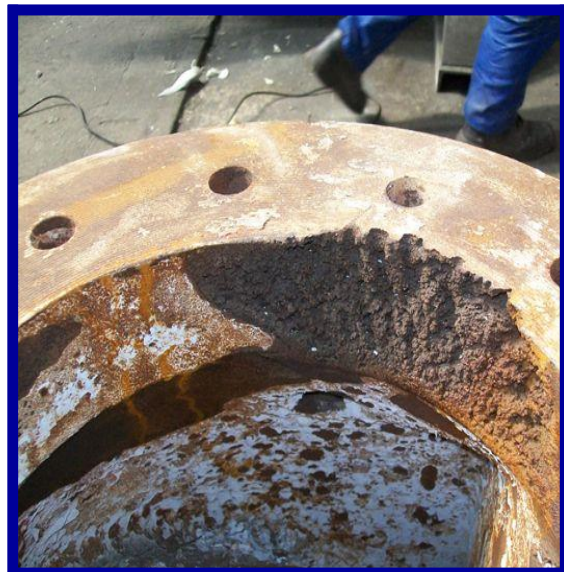
*Middle: Valve bodies suffered severe cavitation damage*

- Multiple abrasive blast cleaning and metallic salt decontamination cycles using CHLOR\*RID until levels of residual metallic salt levels are within acceptable limits.
- Application of CORROCOAT CORROGLASS 600 Series, comprising:-
- Corroglass 632 Primer followed by the application of Corroglass 602 'Putty-grade' material to re-build the lost cast iron using proprietary application techniques & materials, to original specification.
- High-voltage spark testing conducted for QC/QA verification purposes.

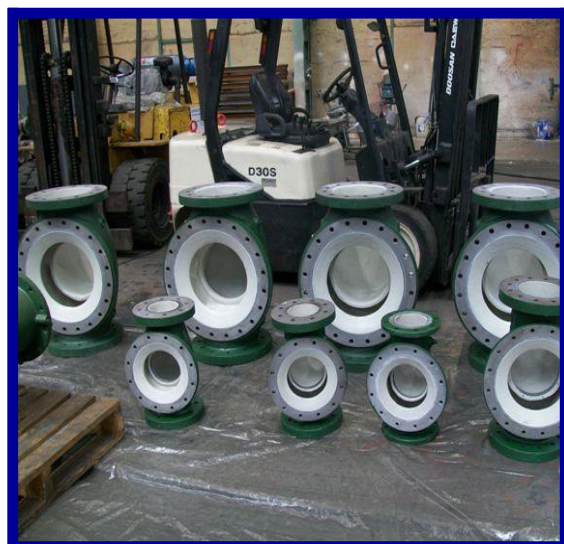
*Bottom: Completely rehabilitated valve bodies*
