# **CASE STUDY : CORROGLASS 600-SERIES IN PUMP**

## **SEAWATER PUMP LINING STILL PERFECT AFTER 25 YEARS**

Nuclear Power Station, South Africa.

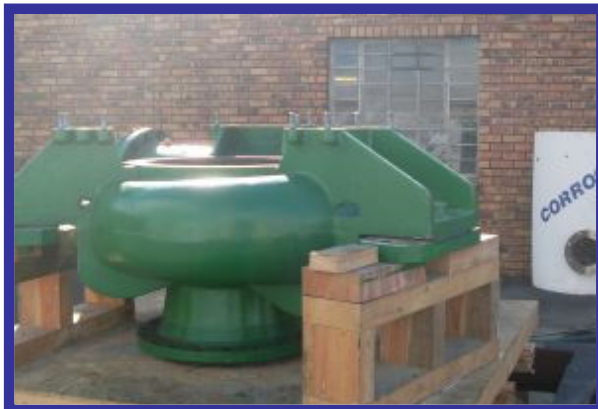
Top: The pump as received after 25 years service

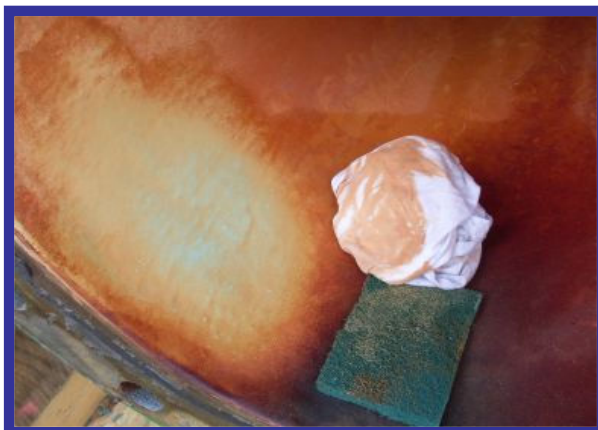
During the service life of continual internal seawater exposure with a low hydrochlorite dosing and high flow, the coating has shown no deterioration, and zero under-cutting, even at the exposed coating edge at the flanges and threaded sockets.

2<sup>nd</sup>: The lining is dirty, but otherwise 100% intact

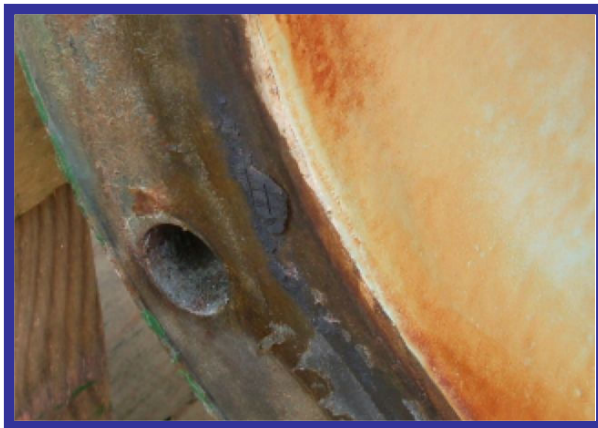
3<sup>rd</sup>: Zero under-cutting at exposed coating edges

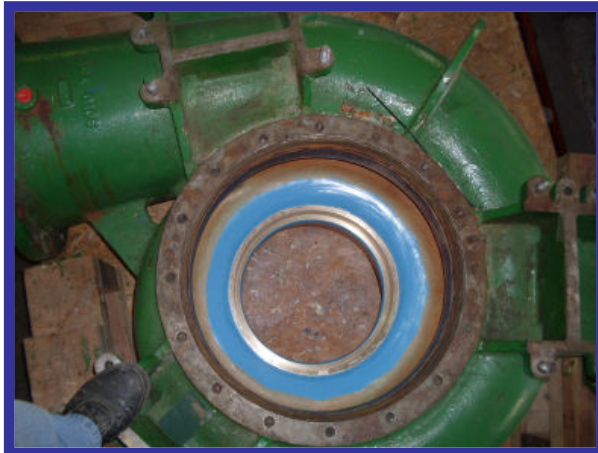
Bottom: Repair area where wear ring was replaced

Repair minor mechanical damage on the volute where the back plate was removed. Recoat back plate 100%.

- Grit blast damaged areas to SA 2½
- Apply Corroglass 600-Series to a minimum DFT of 1.2mm, spark test to 10Kv DC
