# ***Case Study:- 400NB Pipeline. In-Situ Internal field joint lining.***

## **INTERNAL LINING AND EXTERNAL COATING ON POTABLE WATER PIPELINE.**

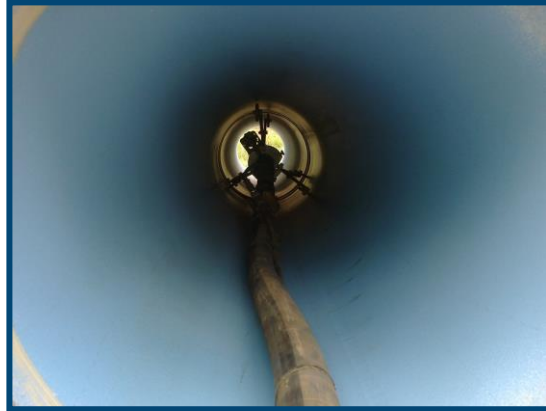
- 1: Pipe sprayer in operation.
- 2: Ventilating 168m length while blast cleaning.
- 3: Access to buried pipe – 96m Either side.
- 4: Coated flange.
