# **CASE STUDY: 7-STAGE COLUMN PUMP COMPONENTS PUMPING SUPER-SATURATED BRINE – COMPLETE REHABILITATION**

## **REHABILITATION & RECLAMATION OF LOST STEEL – THAT'S TRUE RECYCLING!**

A large Soda Ash & Salt Mine, Northern Botswana.

November – December 2019

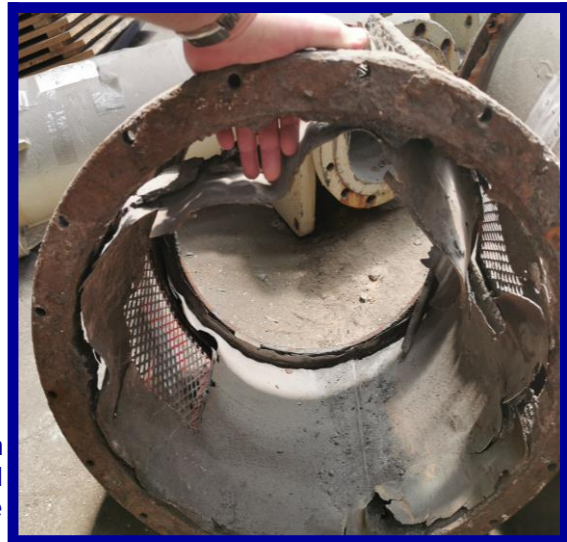
Top: Column Drive Base completely corroded through  
Middle: Following Chlor\*Rid washing & Blast Cleaning  
Bottom: Drive base completely rebuilt & ready for service.
